ROCKWOOD HILLS LAKE DAM

TANEY COUNTY, MISSOURI

**PHASE 1 INSPECTION REPORT
NATIONAL DAM SAFETY PROGRAM**

ROCKWOOD HILLS LAKE DAM
TANEY COUNTY, MISSOURI
MISSOURI INVENTORY NO. 30372

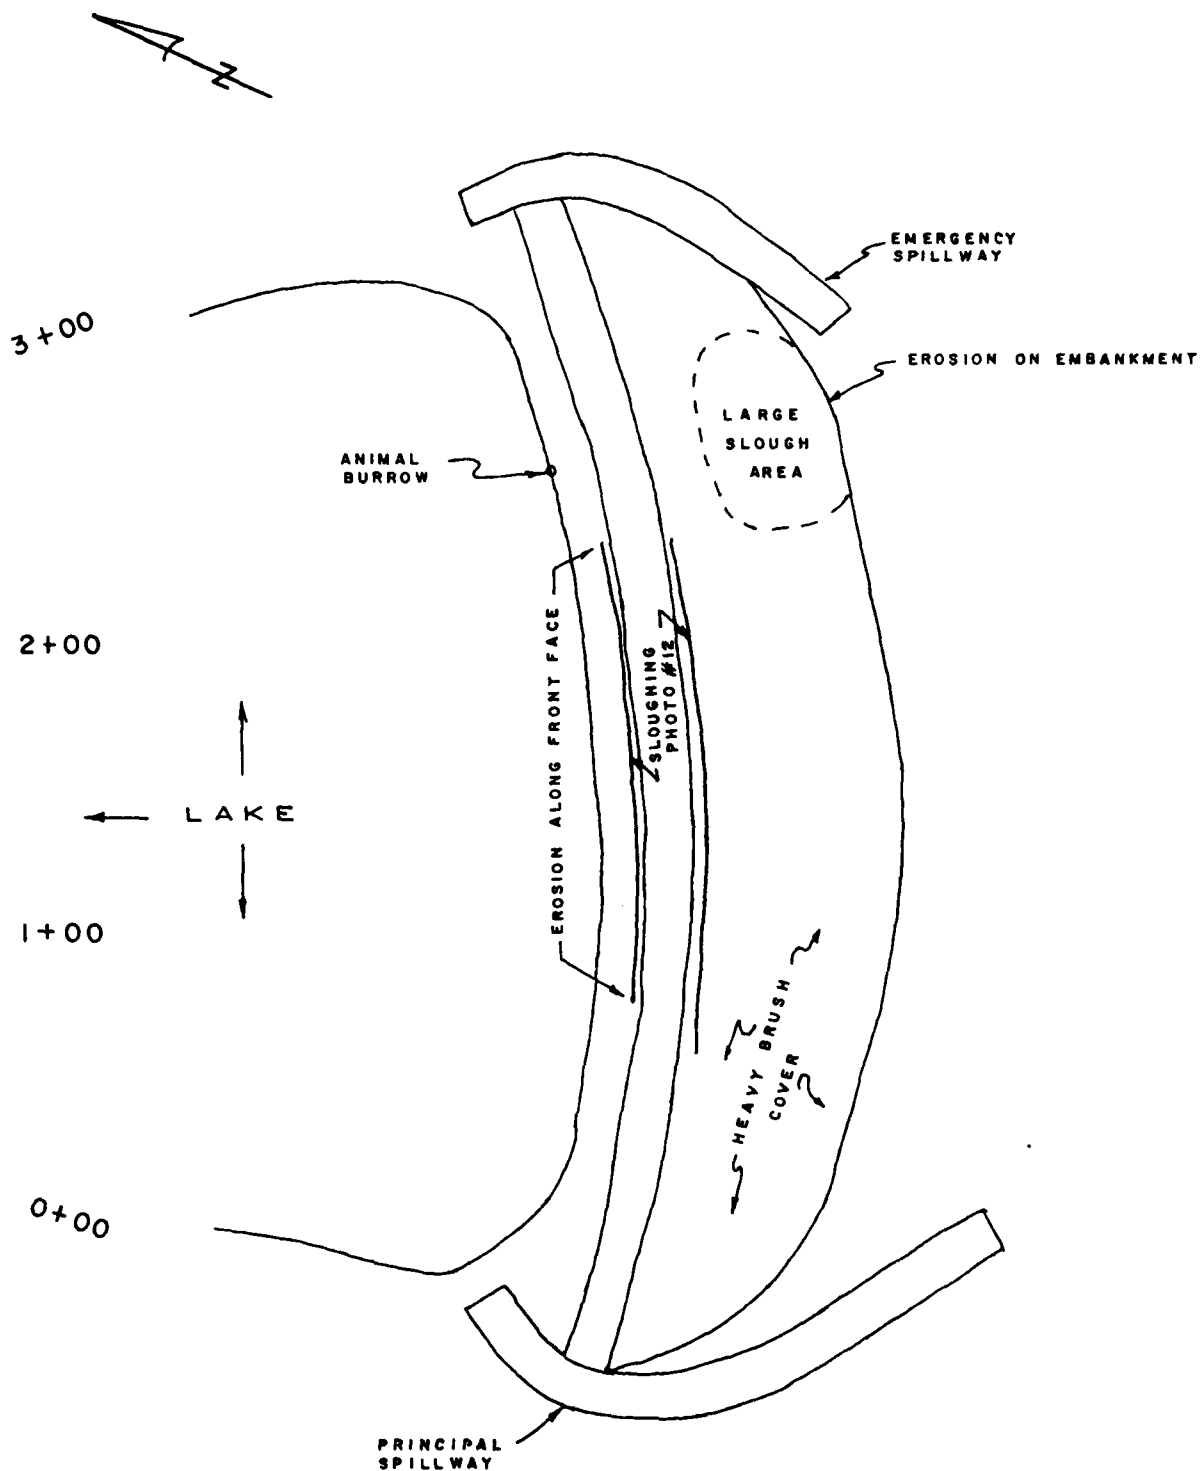
PLAN SKETCH OF DAM
ROCKWOOD HILLS LAKE DAM
TANEY COUNTY, MISSOURI
MO. I.D. No. 30372

The dam appears to be in poor condition. Sloughing was noted along the crest of the dam. A large slough exists along the downstream face near the discharge of the east (emergency) spillway. There was also erosion on the front face of the dam. There was no rip-rap protection.

The downstream face had areas of steep slopes. Heavy wood and brush growth existed on both embankment faces. One large animal burrow was noted just below water level on the upstream face. The horizontal alignment of the dam appeared good.

The concrete spillways have no wingwalls, and there is some erosion between the walls and the dam and abutments. The concrete is in fairly good condition. However, some areas of honeycombing and cracking were noted. Some undermining has occurred at the discharge ends of both spillways.

The discharge of the east (emergency) spillway has eroded into the toe of the embankment immediately below the large slough area. One small discolored seepage spot was observed in the embankment below the large slough area. No flow was detected (See Photograph No. 14).

- (1) Seepage and stability analyses comparable to the requirements of the recommended guidelines should be performed by an engineer experienced in the construction of dams.
- (2) The sloughing areas at the crest and the downstream face near the end of the emergency spillway should be investigated by an engineer experienced in the design and construction of dams. Remedial measures will very likely be required.
- (3) Protection should be provided for the embankment from emergency spillway releases. Further erosion below the large slough area could result in failure of the dam.

- (4) Erosional areas should be repaired and seeded.
- (5) Wave protection should be provided for the upstream face of the dam.
- (6) Tree and brush growth should be removed from the faces of the embankment. Removal of trees should be under the supervision of an engineer experienced in the design and construction of dams. Indiscriminate clearing methods could jeopardize the safety of the dam.
- (7) The vegetative growth on the dam should be cut periodically.
- (8) Wingwalls should be constructed at the entrance to both spillways.
- (9) Undermining of both spillway discharge ends should be corrected to prevent further deterioration of the concrete chutes.
- (10) The animal burrows should be repaired and maintained.
- (11) A detailed inspection of the dam should be made periodically by an engineer experienced in the construction of dams.
